PRELIMINARY REPORT ON MONITORING OF WATER TABLE AND SALINITY USING PIEZOMETERS IN THE MAKHATHINI IRRIGATION SCHEME

**Department of Agriculture, Forestry and Fisheries
Directorate: Water Use and Irrigation Development**

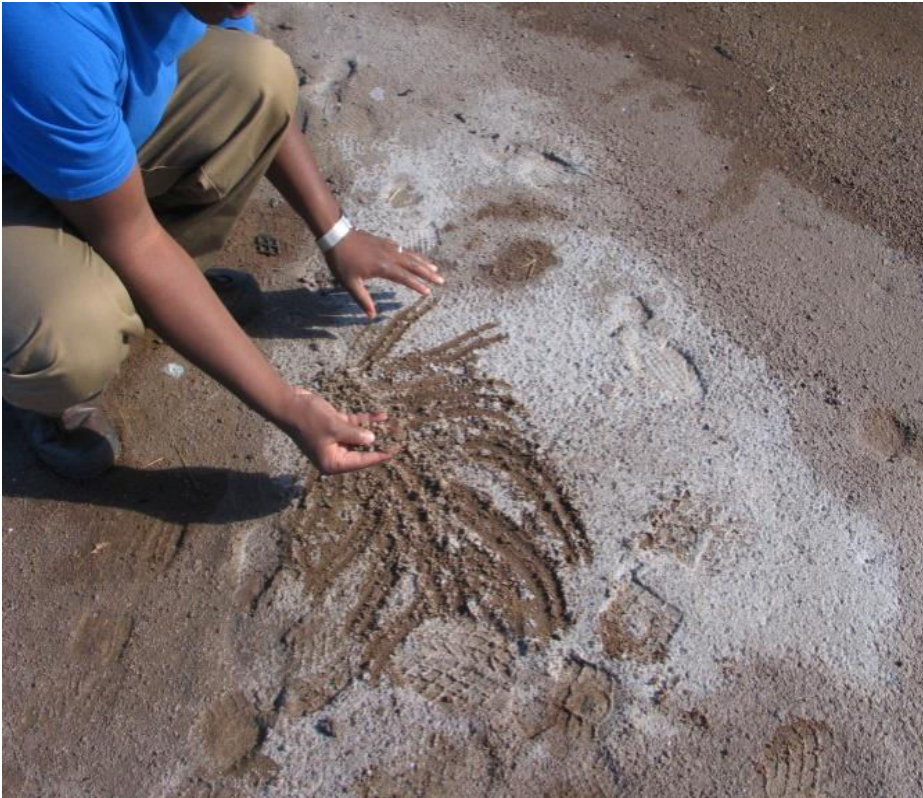
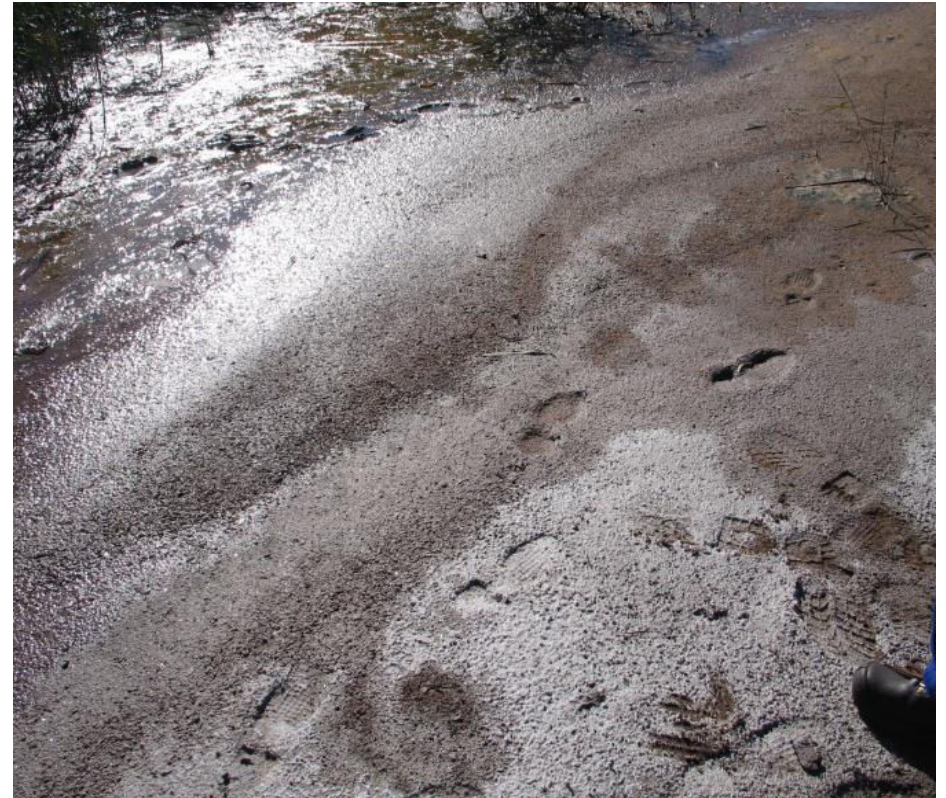
- Salinity is also a problem in the scheme – these is a result of movement of salts stored in the soil profile and the surface

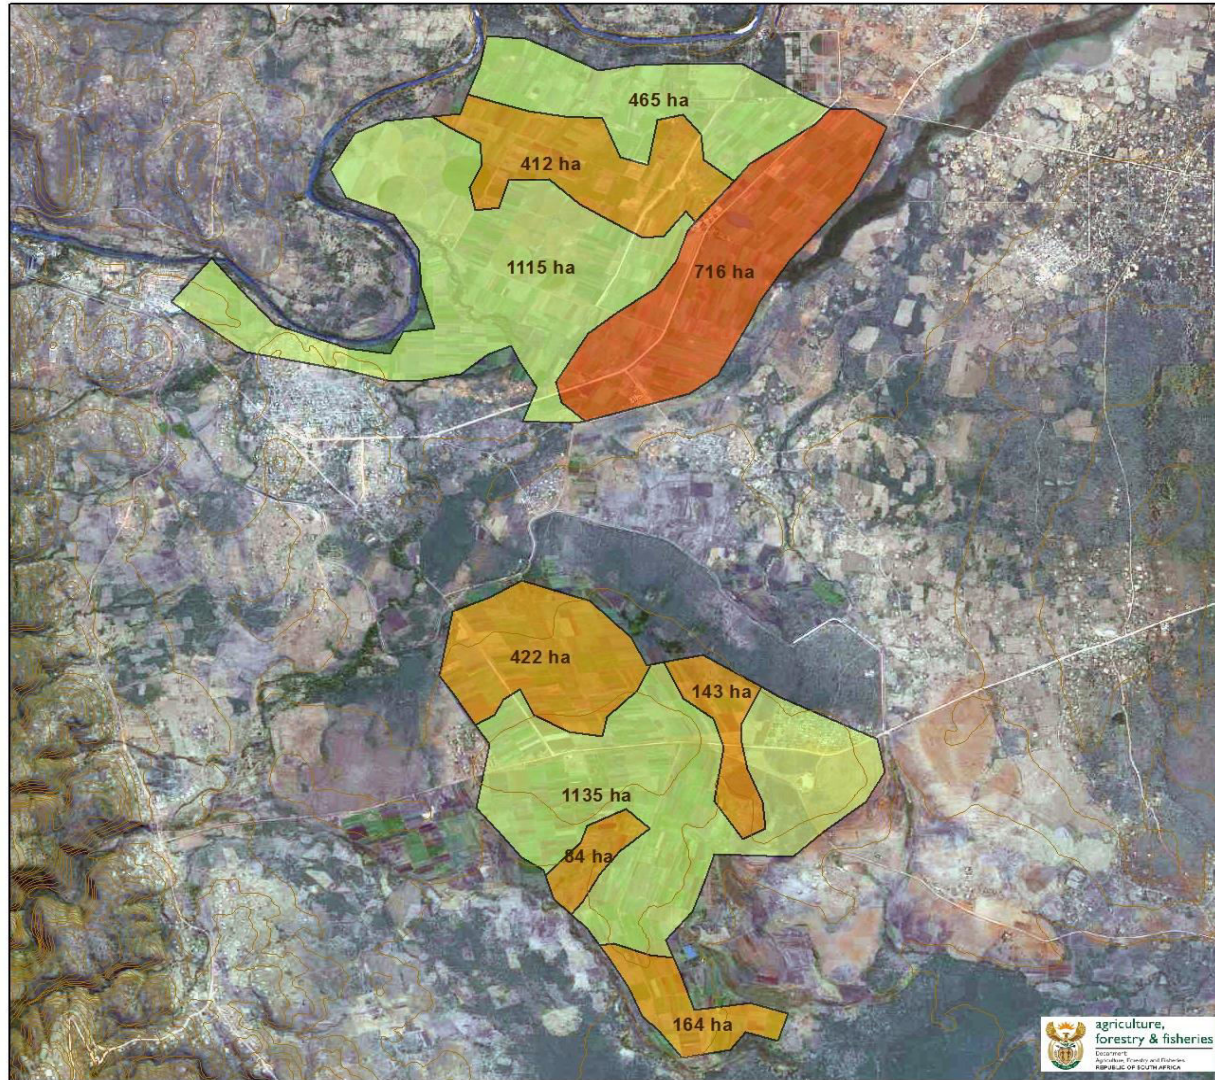
MAKHATHINI DRAINAGE MAP

Drainage Problem
-

Potential Drainage Problem

- Field observations show that there is poor irrigation management
- Drainage problem was identified in Block 19. A design for a sub-surface drainage system was recommended
- It was also recommended that after the installation of the sub-surface drainage system in Block 19, the area will need to be monitored to determine the impact of the sub-surface drainage system on the water table and plant growth
- It is recommended that the area with potential drainage problems be monitored on bi-annual basis
- It is recommended that farmers be trained on irrigation management
- It is recommended that farmers be provided by gypsum to apply in the affected areas
